Docket No. 217 – Development and Management Plan Inspection

Northeast Utilities Service Company Certificate of Environmental Compatibility and Public Need for the construction of a 345-kV electric transmission line and reconstruction of an existing 115-kV electric transmission line between Connecticut Light and Power Company's Plumtree Substation in Bethel, through the towns of Redding, Weston, and Wilton, and to the Norwalk Substation in Norwalk, Connecticut.

Date: December 8, 2005

Location: Transition Stations: Hoyts Hill, Archers Lane, Norwalk Junction

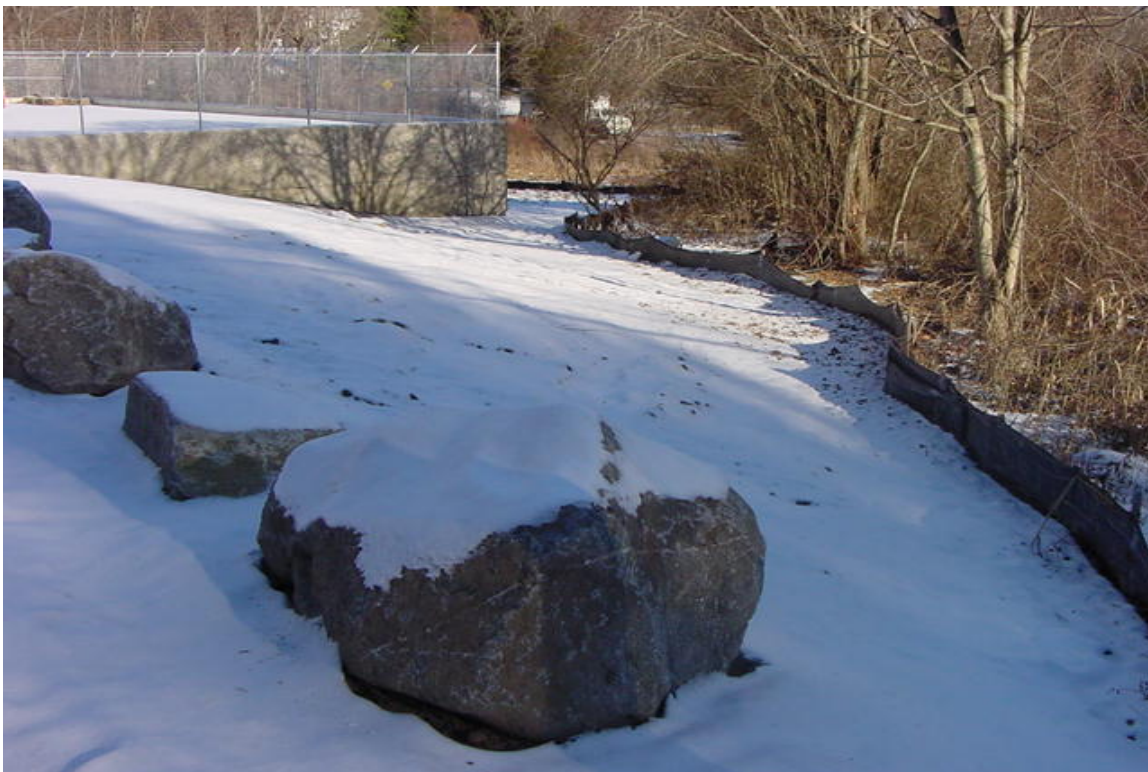
Hoyts Hill Transition Station: View of the site with snow cover, looking along the southern perimeter silt fence. Perimeter controls are still in place. 12/8/05

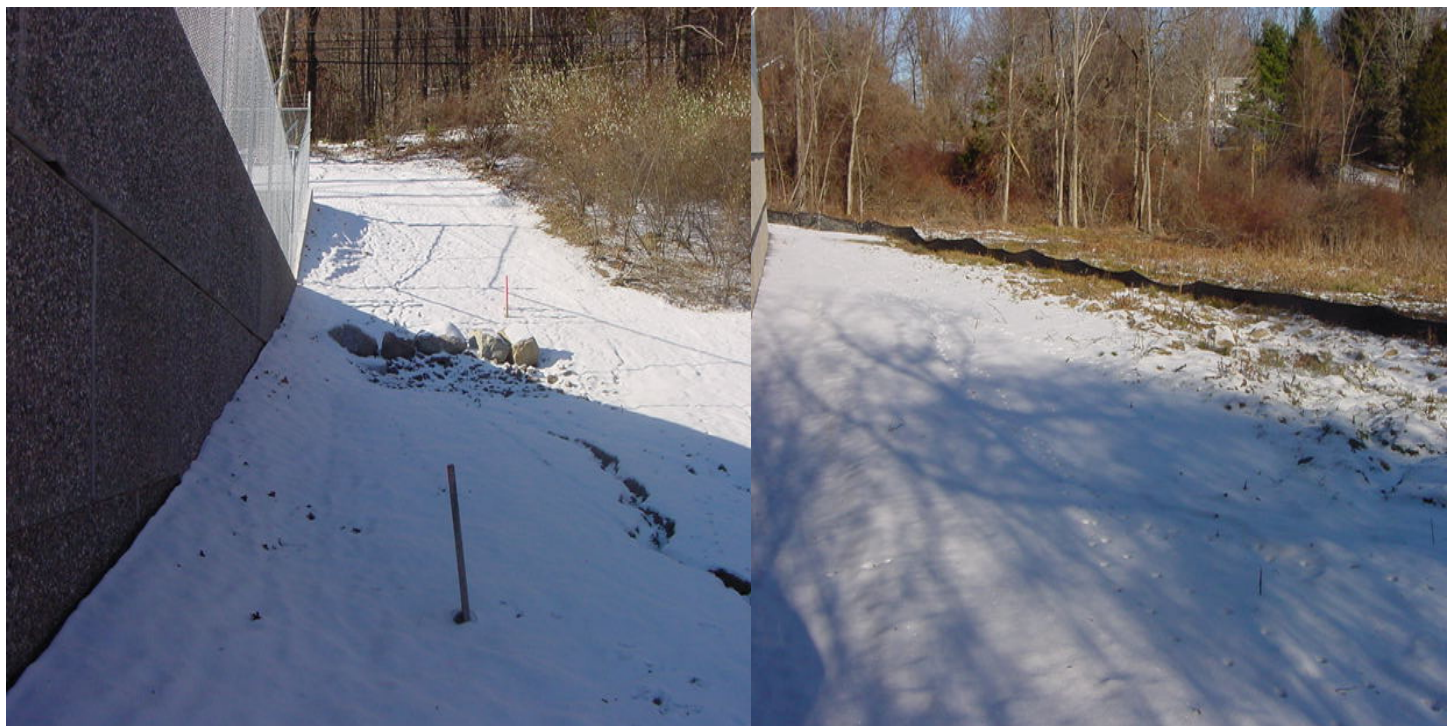
Areas of Inspection	Observation	Recommended Action
Erosion and Sediment Controls continued	<ul style="list-style-type: none"> - Erosive gullies were still present along both the northern and southern slopes under the snow cover. 12/8/05 - The gullies have caused sediment to deposit all along the base of slope. 10/27-12/8/05. -The gullies appear to begin at the outlet pads. It may be necessary to extend the pads since they are not reducing velocity appropriately. 11/02-12/8/05. - Archers Lane: Monitor stormwater run-off velocity off the engineered slope. This area is steep and water used to collect at the base at the silt fence. 12/8/05. 	<p>and a stronger method of stabilization, such as erosion control mats, should be considered if the grass cannot stabilize before the ground freezes. 12/8/05.</p> <p>-Investigate whether extension of the stone pad would help the situation and restore the erosion caused here. Contractors were discussing placing haybales at the outlets here. This may not be enough structure but it can be attempted. 12/8/05.</p> <p>- Continue to monitor this area, especially after significant rain events. This is where sediment had previously collected. 12/8/05.</p>

Photo on the left shows the northern outlet with erosive gullies still visible under the snow. The photo on the right shows the silt fence along the eastern perimeter wetlands. Water was observed running clear through this area. 12/8/05.

Erosion and Sediment Controls (includes inspection within 24 hours of a storm event)	<p>-Hoyts Hill: The majority of the perimeter silt fence remains in good condition and water was seen running clear through the barrier. 12/8/05. A small amount of sediment had filtered through the fence as of a few weeks ago-continue to monitor. 12/01-12/8/05.</p>	<p>- Continue to monitor the area and be proactive in maintenance of the erosion controls, especially in areas with wetland immediately adjacent. 12/8/05.</p> <p>- Gullies should be repaired</p>

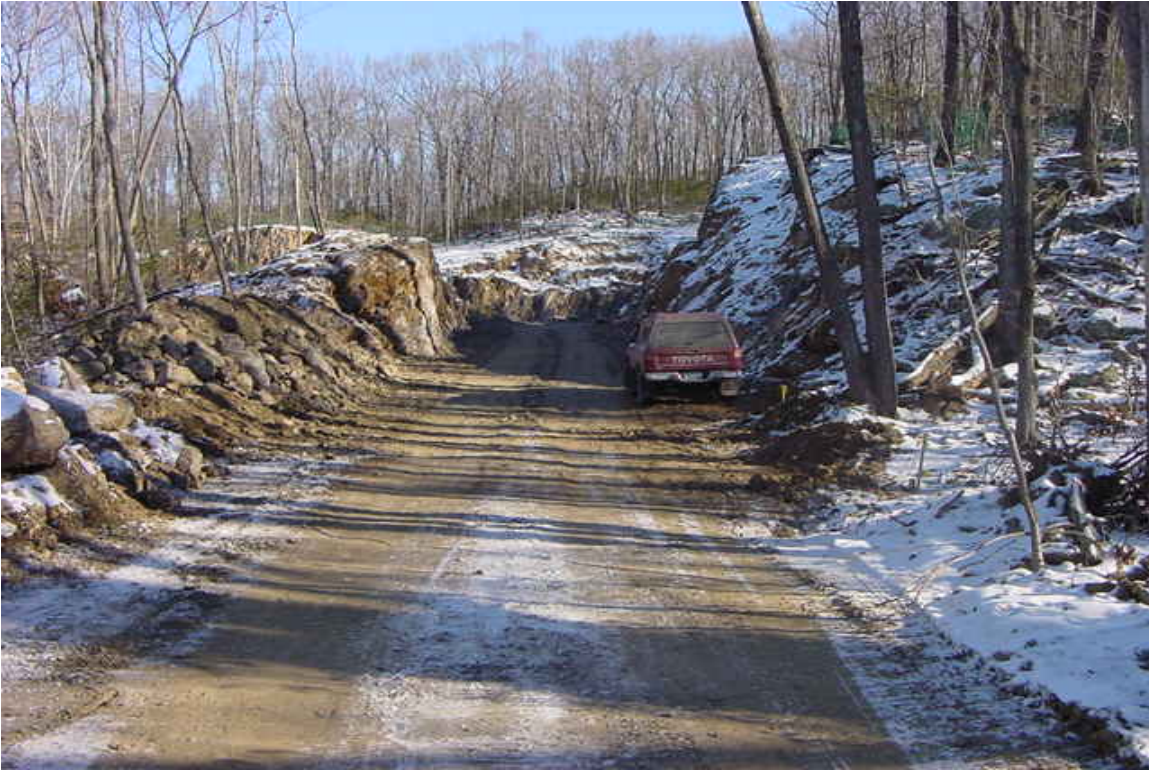
Archers Lane: View of the completed upgradient access road into the site. All extraneous rock has been removed and hauled away. 12/8/05.

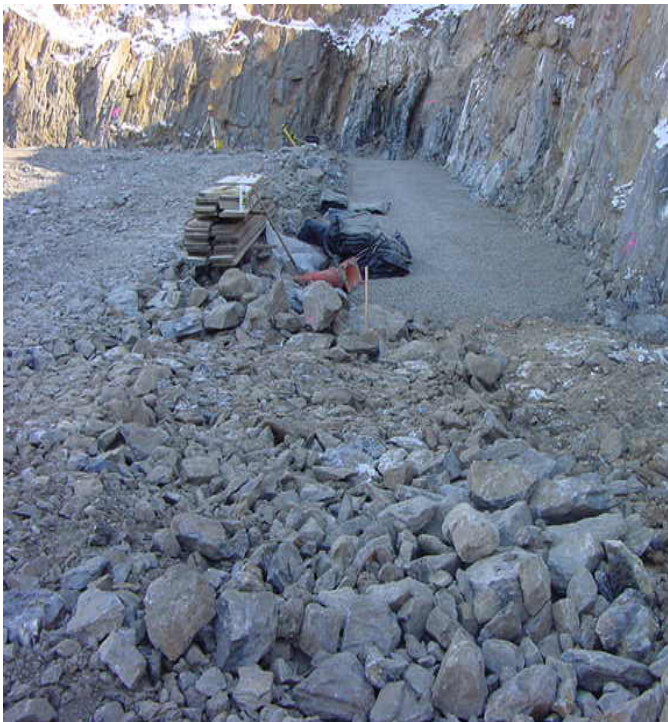
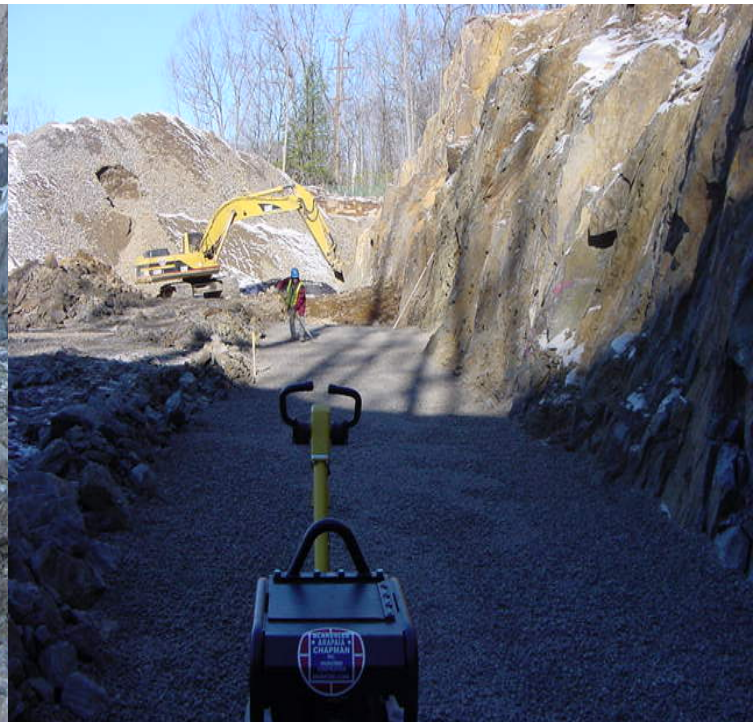
Both photos show stone leveling in preparation for retaining wall footings. 12/8/05.

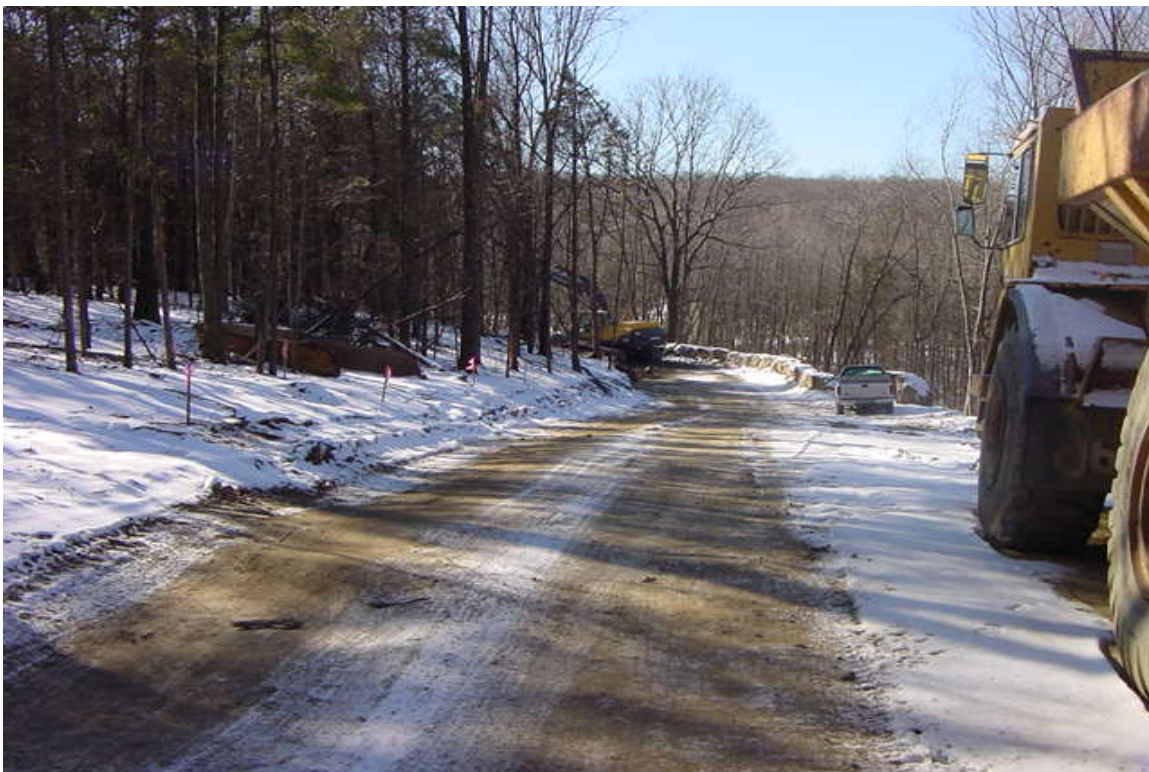
View of the access road into the site where stone is being placed along the property line in response to an adjacent landowner's request. 12/8/05

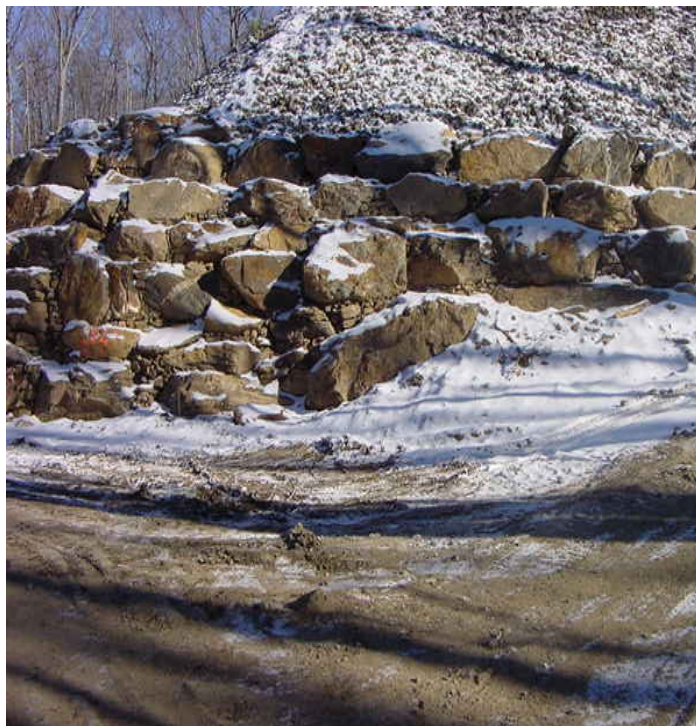
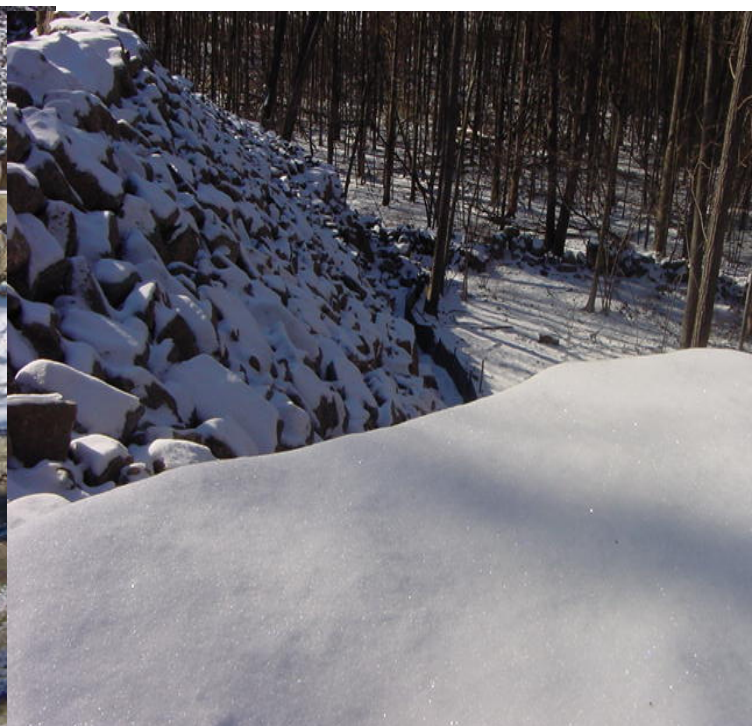
Photo on the left shows stone wall construction at the lower access road to the site. Photo on the right shows an engineered stone wall off the access road. 12/8/05

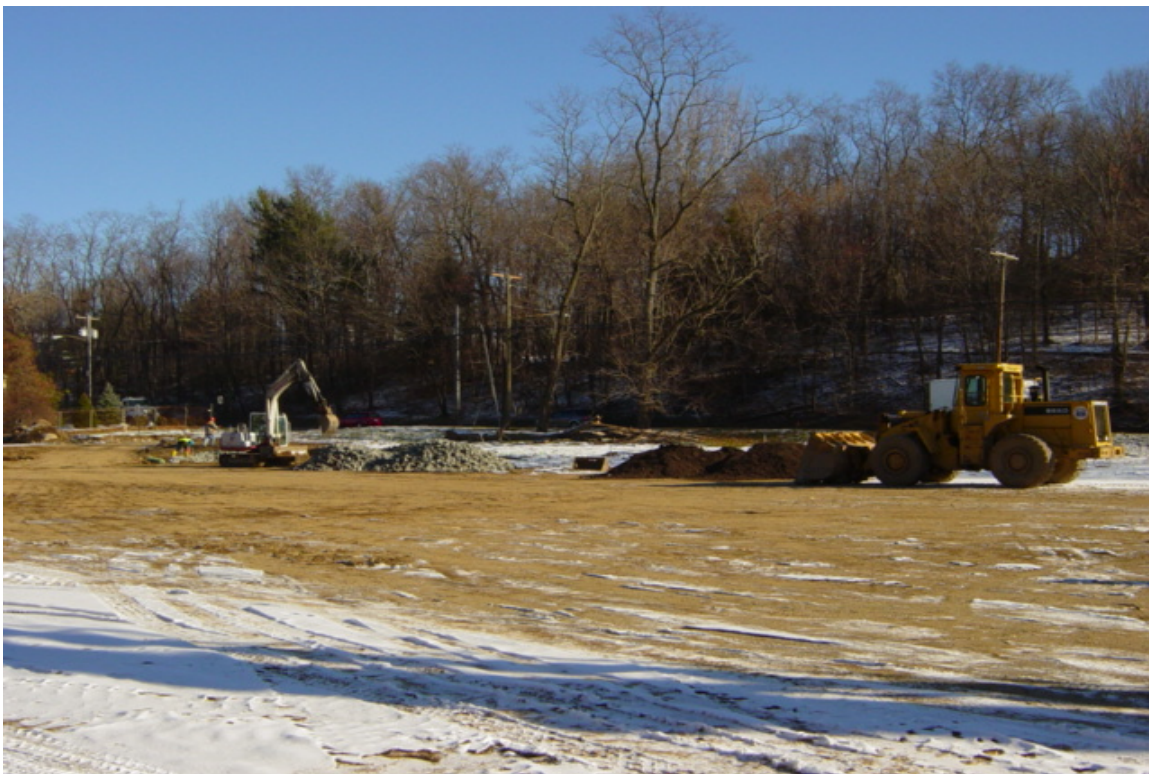
Norwalk Junction: View of the overall yard with several small stone and soil stockpiles. Stone is being placed in the swale along the access road as part of the new drainage work. 12/8/05

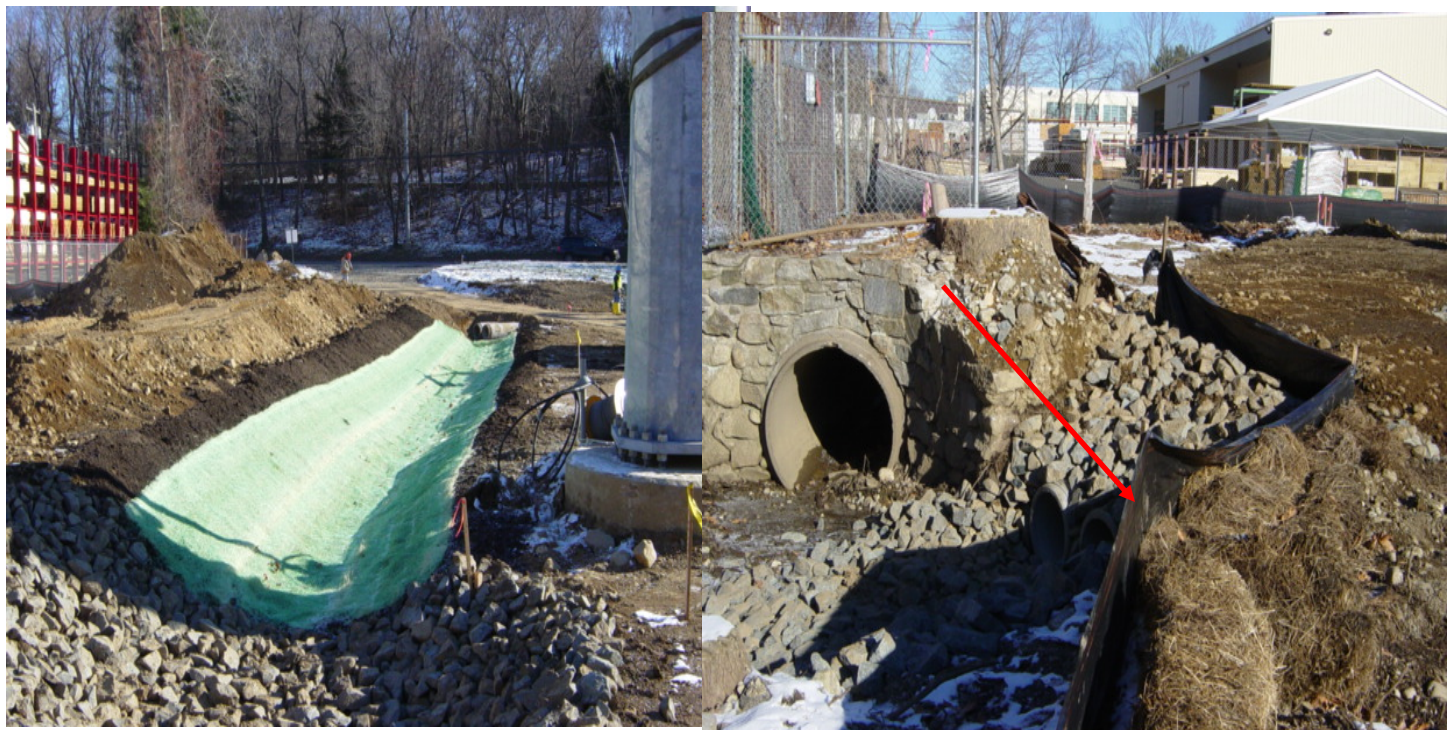
Photo on the left shows the work to install the new drainage way along the access road into the site. Photo on the right shows where the new pipe outlets with stone riprap placed along the slope. A haybale should be placed at the outlet for now until the work is complete and stabilized. 12/8/05
